Home Inspection Report

2774 Barron Road, Overland Park, KS 66215
Inspection prepared for: Robert & Patricia Smith
Date of Inspection: 4/1/2016

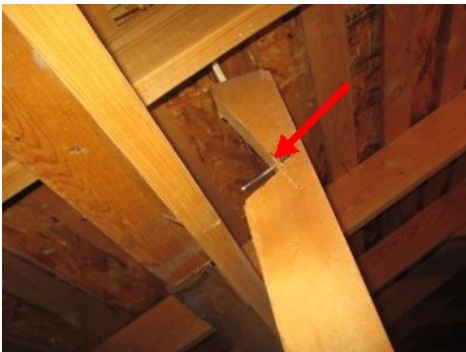
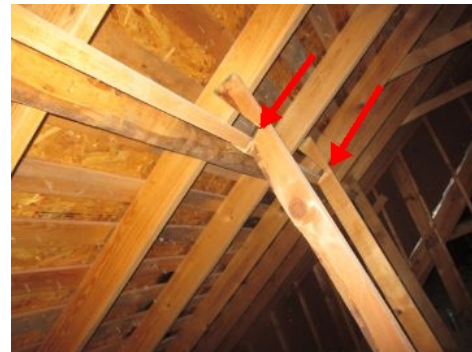
- Repair: Noted roof bracing at front side of home (as seen in attic) were miscut and offered little support. Recommend replacing braces.

Roof braces miscut and loose

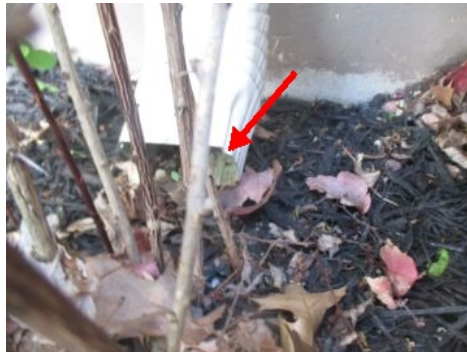
- Repair: Downspouts should discharge water 24-36" from foundation to help prevent foundation damage and moisture intrusion. Recommend adding plastic extensions or French drains (underground extensions).

Extend downspout

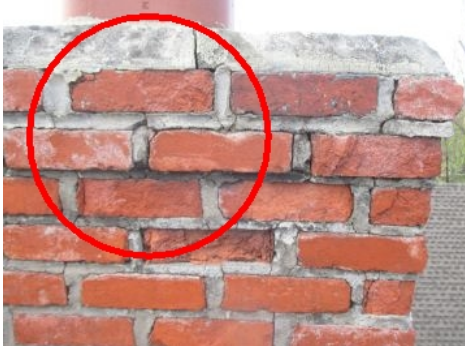
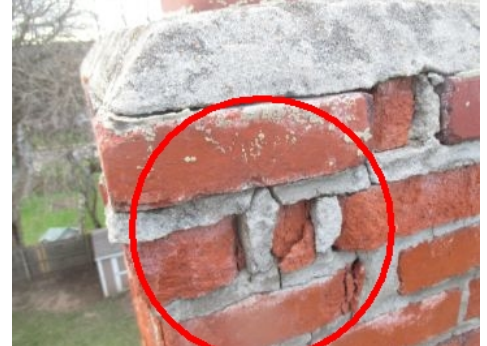
- Repair: Noted several areas of spalling (flaking) on the chimney. This is a common condition of masonry chimneys. Recommend repair.
- Repair: Noted the concrete chimney cap was damaged/cracked. Recommend repair/sealing.

Replace mortar

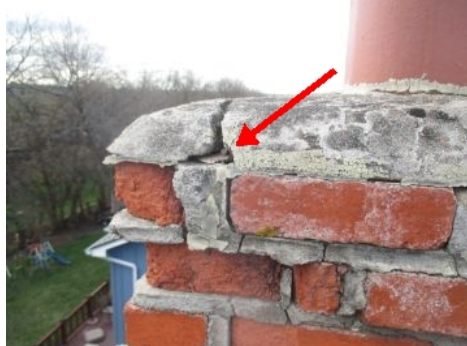
Damaged chimney cap

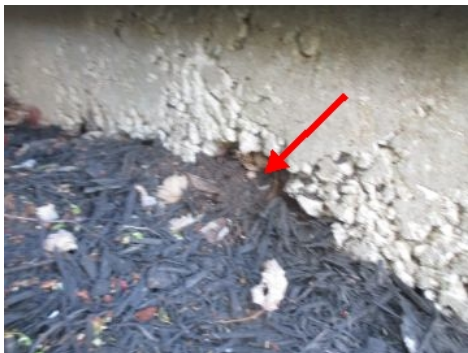
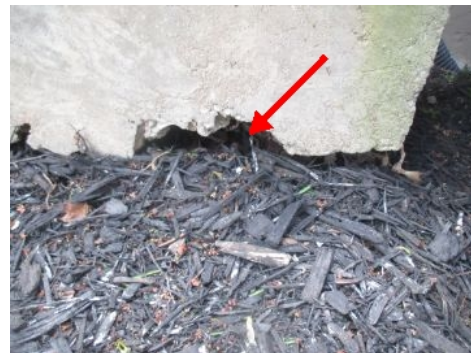
- Repair: Noted a small void underneath front porch. Recommend filling void with concrete or chat to prevent porch separation and prevent animal intrusion.

Small void under front porch

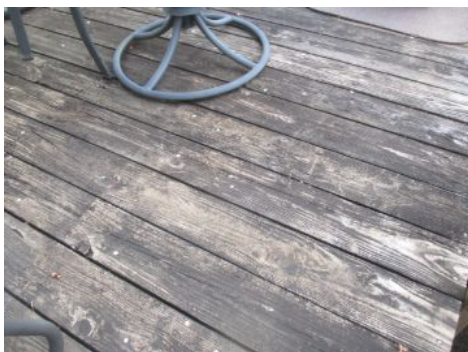
Paint/stain deck

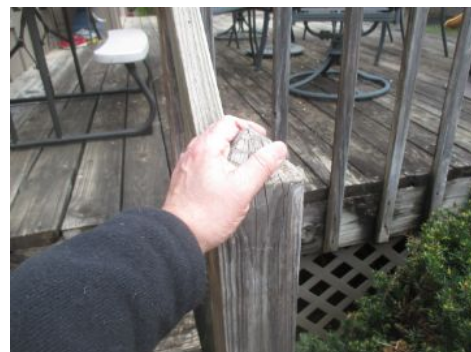
Loose handrail

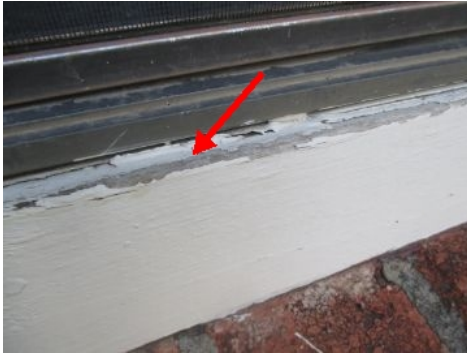
Flaking paint at front of home

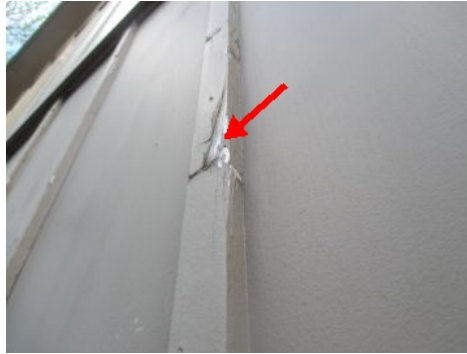
Flaking paint on right side of home

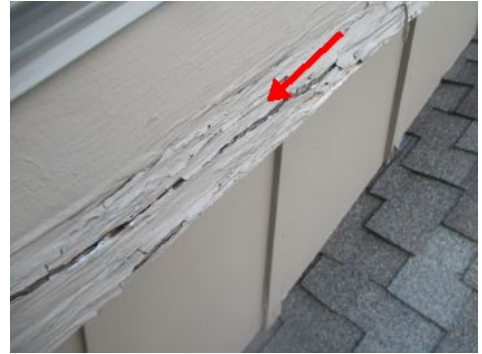
Damaged fascia board on roof

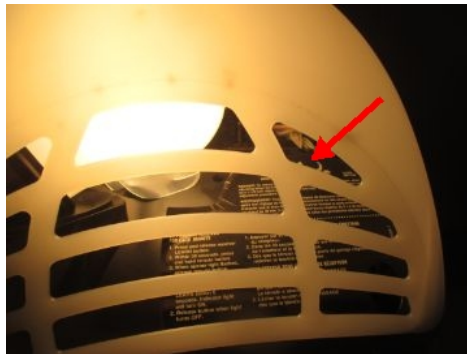
- Safety Issue: The garage door's auto reverse was unresponsive. When the garage door meets 5 PSI of resistance it should reverse its course. This problem can be easily corrected by adjusting the tension screws on the garage door opener's main box.

Adjust down force here

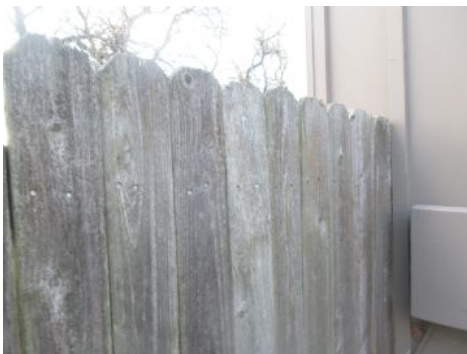
Paint/stain fencing

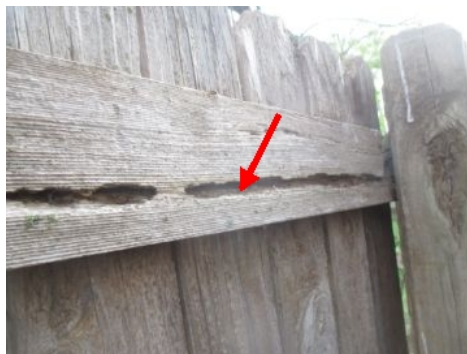
Damaged fencing at left side of yard

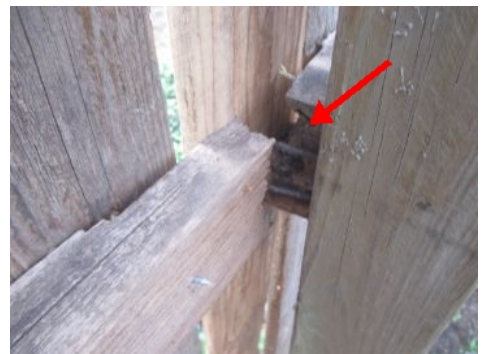
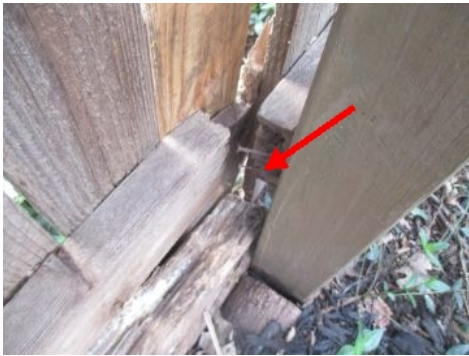
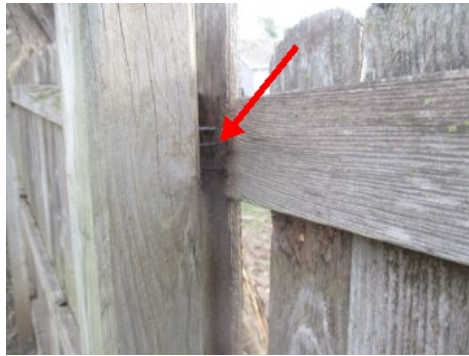
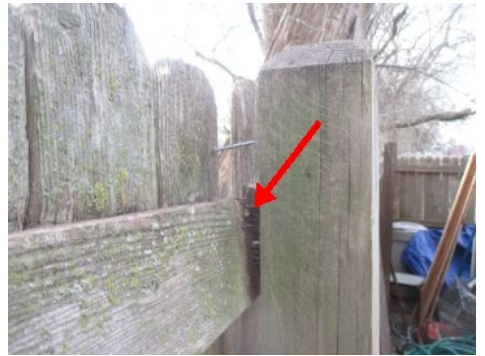
Damaged fencing at back side

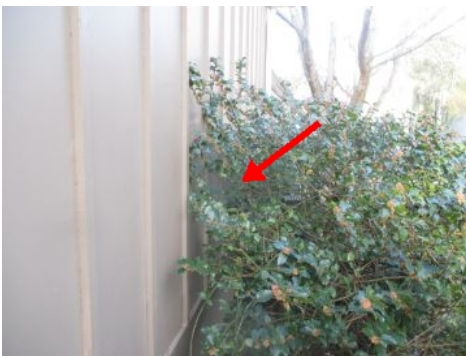
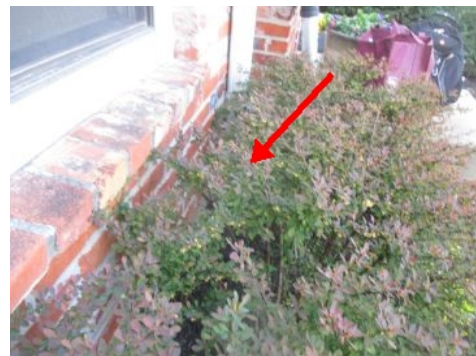
- Repair: Shrubs should be cut back 6-8" inches away from wall to prevent siding damage.

Cut back bushes

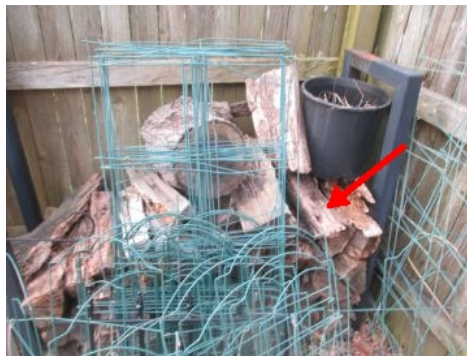
- Repair: Recommend moving firewood away from house at least 30 feet, as it invites termites.

Move firewood

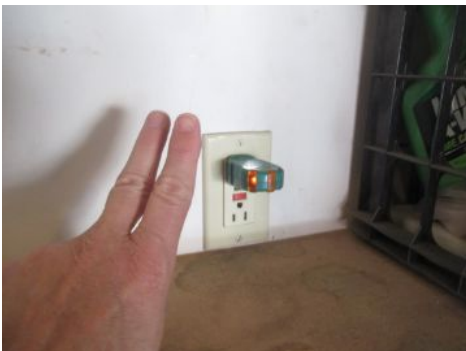
Bathroom GFIs reset in garage

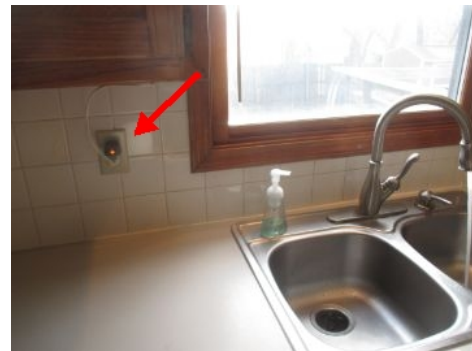
Install GFIs in kitchen on both sides of sink

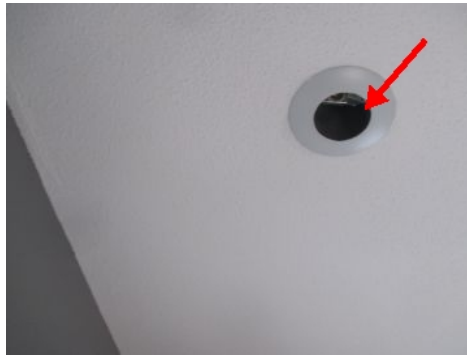
- Repair: Observed an inoperative light in middle back bedroom. Recommend repair/replace burned out bulb.

Missing light in middle back bedroom

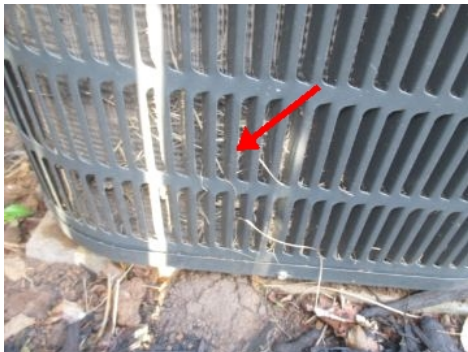
Clean grass from AC unit

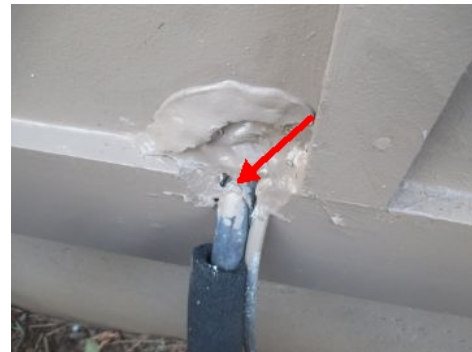
Seal gap

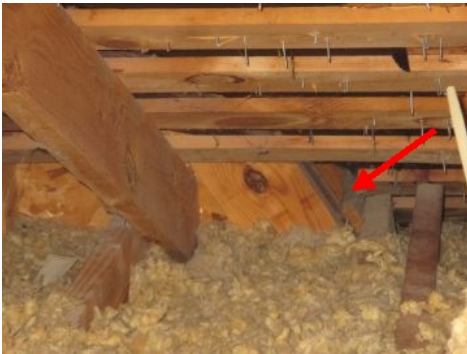
Bird located in space above front door

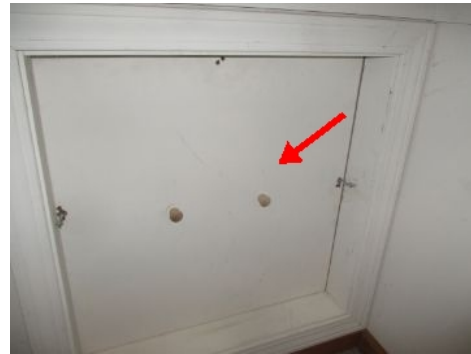
Insulate access panel to attic

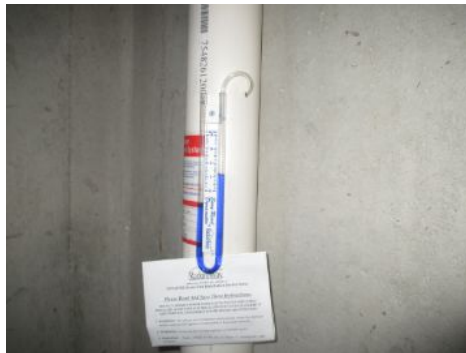
- Monitor: Recommend periodic monitoring of radon mitigation system. When viewing vacuum monitor installed on PVC pipe in basement. An uneven liquid level indicates the system is operative.

Radon vacuum monitor in basement

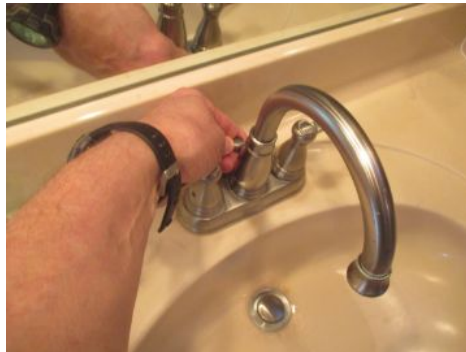
- Repair: Lift rod (controls the stopper) at right sink in master bathroom was inoperative. Recommend reconnecting lubricating.

Inoperative lift rod in master bath

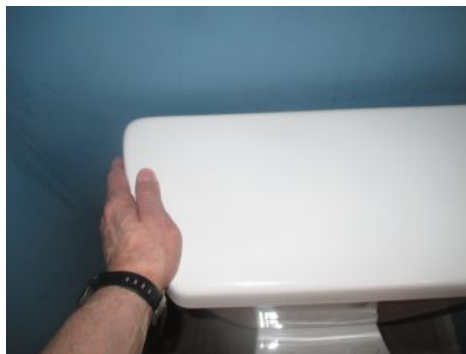
- Repair: Toilet tank in the basement bath is loose. Recommend tightening.

Loose tank in basement bath

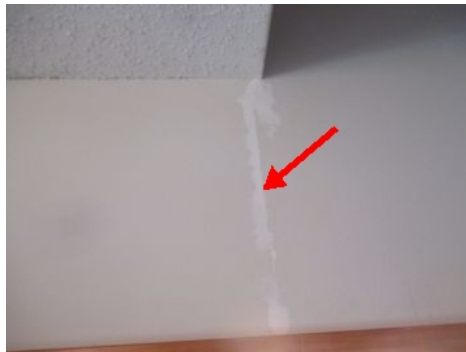
- Monitor: Observed moderate drywall cracking in entry hall and left bedroom. This type of cracking is typical with drywall construction and is not usually a structural deficiency. Monitor for further damage and repair if necessary.

Drywall crack in hallway

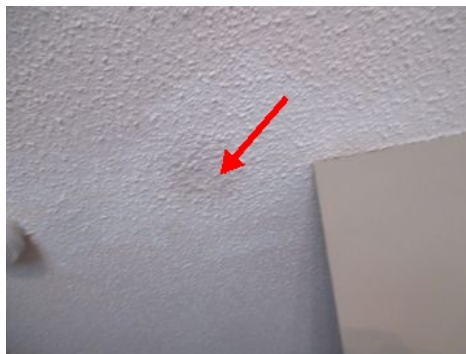
- Monitor: Noted a moisture stain in the hallway ceiling. The stain was dry at the time of inspection and does not appear to have occurred recently. Recommend conferring with current owner for details and monitor for spread.

Water stain in hallway

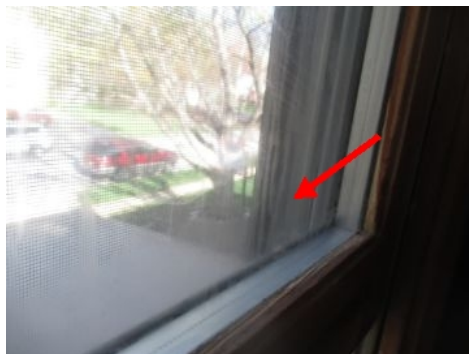
- Repair: Noted window in middle front bedroom with broken seal, resulting in interior staining of double-pane glass. Recommend replacement of glass and having a window specialist evaluate all windows in home for similar defects.

Window in middle front bedroom with broken seal

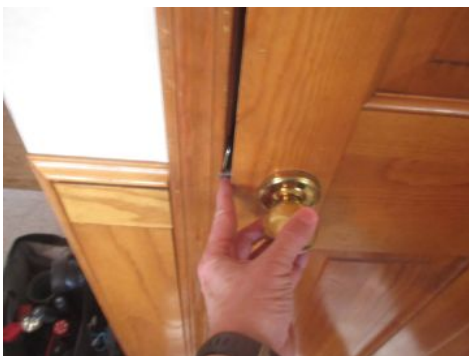
Basement door won't latch

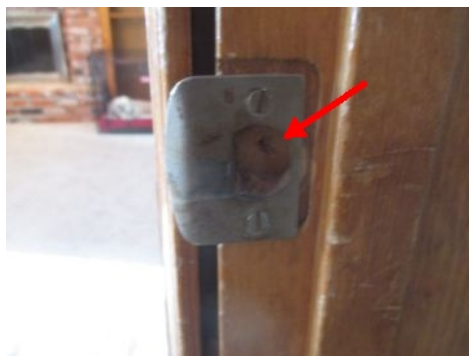
Realign strike plate for doors that won't latch

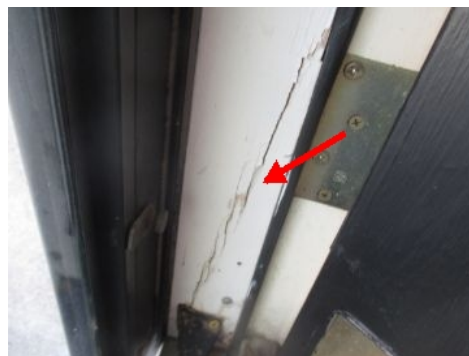
Damaged door jamb

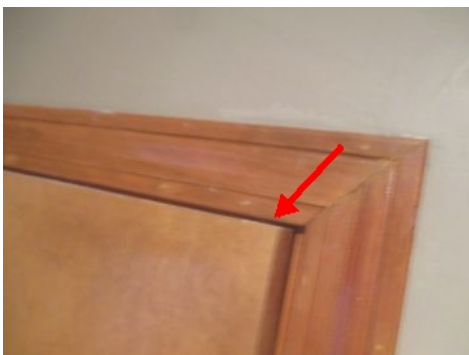
Bathroom door sticks at top

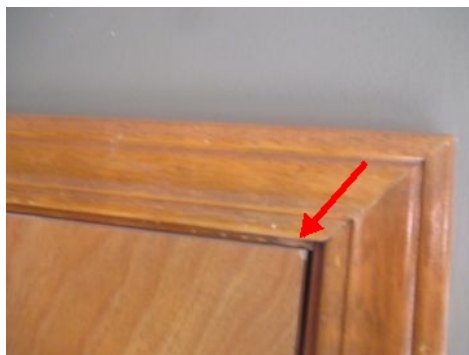
Hall door to master bedroom sticks at top

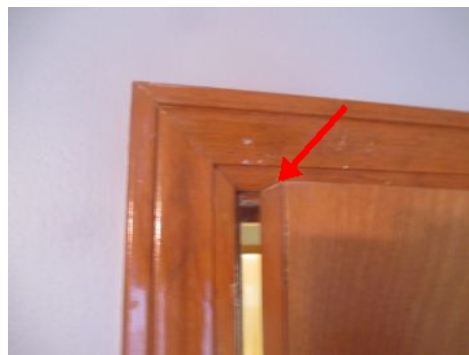
Hall door to middle front bedroom sticks at top

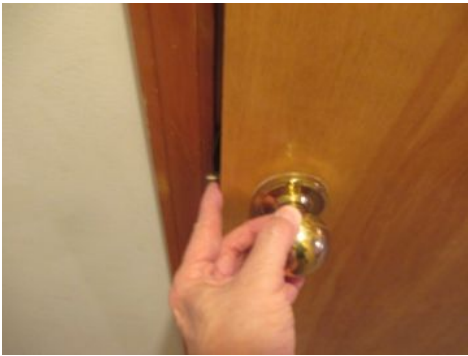
Linen closet door won't latch

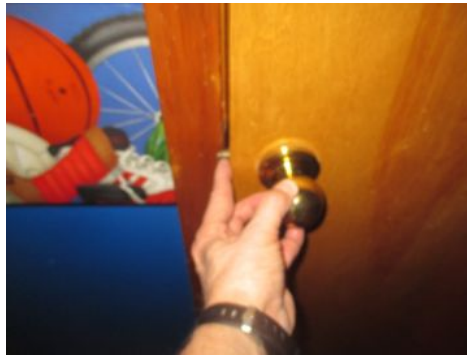
Bedroom door won't latch

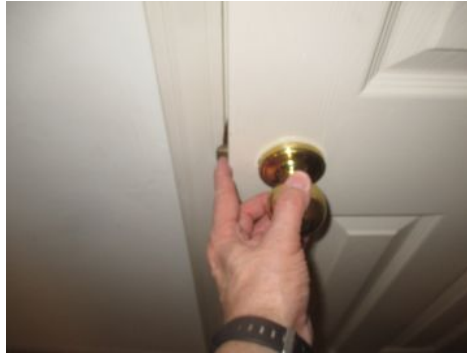
Basement closet door won't latch
